Tree Condition & Management Report

Hertford Heath Parish Council | 24 April 2016

Client:	<i>Hertford Heath Parish Council</i>
Contact:	<i>Jo Hole (Parish Clerk)</i>
Site:	<i>Report covers multiple sites</i>
Prepared by:	<i>Paul Melarange BSc (Hons) M.Arbor.A</i>
Date:	<i>24 April 2016</i>
Version	<i>01</i>

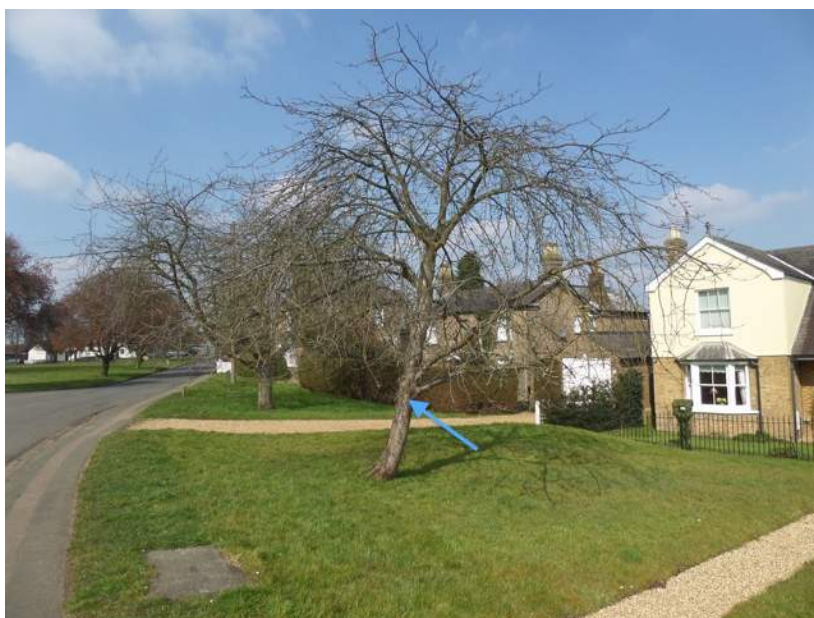
Figure 5. Tree No.17 (arrowed).

Tree 17 is a mature cherry (Figure 5) located on the section of Mount Pleasant Green between the road and house No.19. Fruiting bodies consistent with those of the fungus *Ganoderma sp.* were observed at the base on the north. When tested with a mallet, the base sounded hollow. Further investigation using a probe confirmed that there is extensive decay at the base on the south-east side. The decay is likely to effect the fracture stability of the tree and increase its risk of failure. However, the tree leans to the east (away from the road) by approximately 17° from vertical. Consequently, if the tree fails it is unlikely to cause damage or harm. It is recommended, therefore, that the owner of the adjacent property is consulted regarding the options available for managing the tree, as if it falls across their pathway it may cause them some inconvenience. If they are happy to accept this associated risk, the tree may be retained. However, if they are not prepared to allow the tree to fail, it should be removed within the next six months.

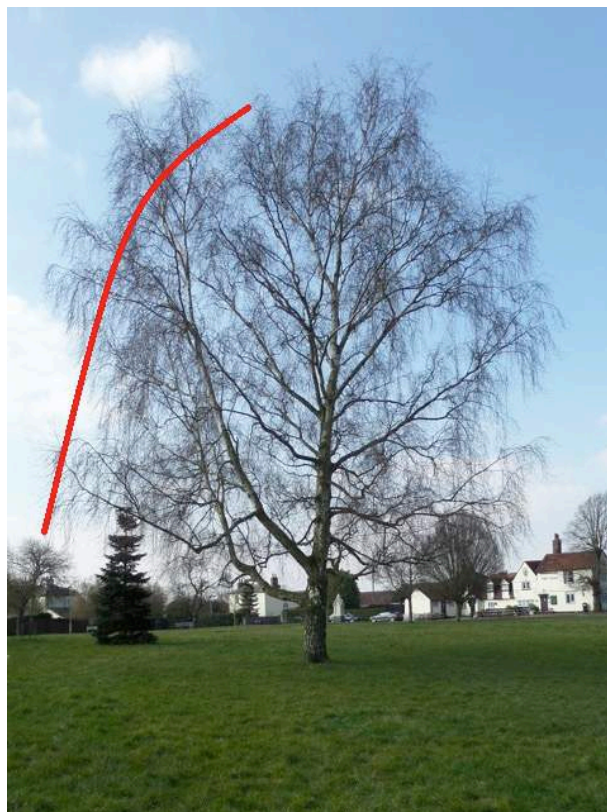
Figure 6. Tree No.16 (curve indicates shape of proposed crown after pruning).

Tree 16 is a mature silver birch (*Betula pendula*) located on the south of the main village green. There are two competing stems on the south and south-west sides of the tree. It is recommended that these be reduced by approximately 2.5-3m within the next two years. Figure 6 (below) is annotated using a curve to indicate the shape of the proposed crown after pruning.

T 14		1	Pyrus calleryana Ornamental Pear	Grass.	Semi Mature	7	4	High	Good	40+	Bark wound - Minor. Epicormic growth - Base / bole / principal stems. Staked tree / trees. Stake - Remove tree stake / strap. not set		
T 15		1	Abies sp. Fir sp.	Grass.	Semi Mature	13	6	High	Good	40+	No significant faults observed. There are christmas lights in the tree.		
T 16		1	Betula pendula Silver Birch	Road within falling distance of tree. Recreational area within crown spread. Grass.	Mature	57	16	High	Good	20-40	There are two competing stems on the south and southwest. Reduce specified limb / limbs - reduce height of the two competing stems on the south and southwest by approximately 2.5-3m. 2 years
